Analysing panel damage after a hailstorm

Hailstorm in the Netherlands

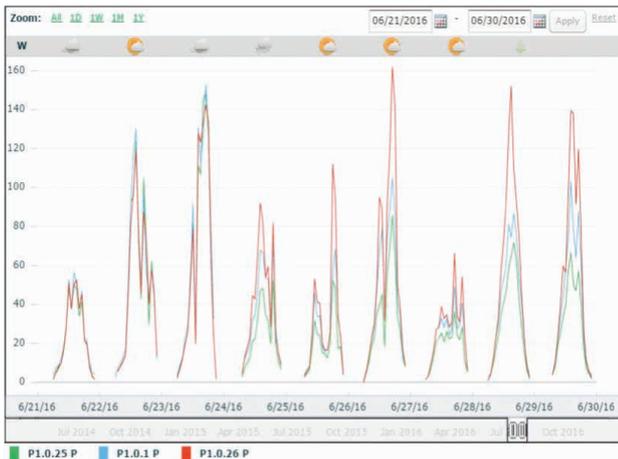
By analysing and comparing the performance of three panels in a PV system, a noticeable decrease in production for two of the panels can be seen beginning on June 24, 2016, one day after the hailstorm.

The graph for Site 1 shows failing panels **P1.0.25 P**, **P1.0.1 P** compared to reference panel **P1.0.26 P**.

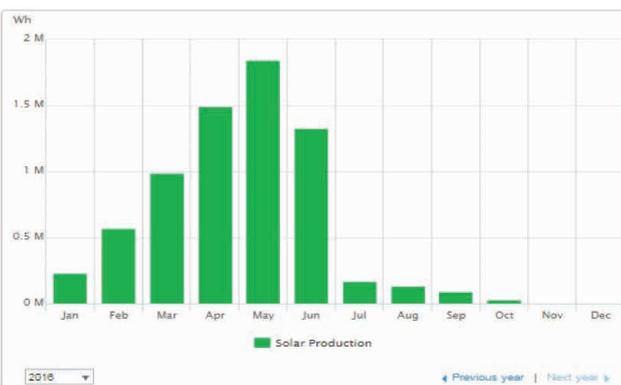
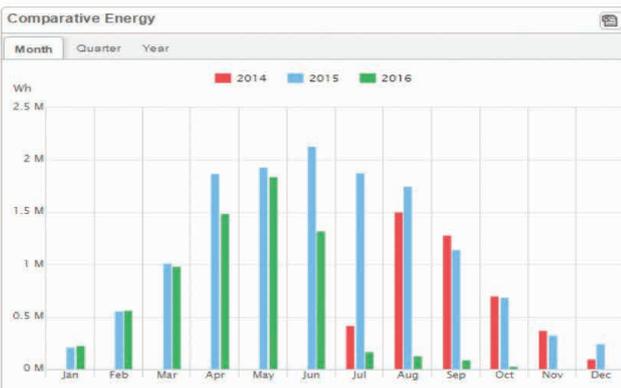
By analysing the total system output of the affected site over a longer period of time, there is a marked dip in system energy production starting in June, which continues to decrease over the months that follow.

The graphs for Site 1 show the difference in monthly energy production.

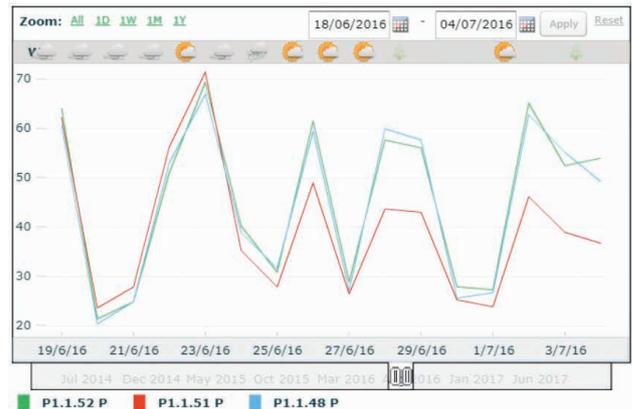
The graph below compares the power production of three panels over a seven-day period before and after the hailstorm. The chart shows normal production up to and including June 23, 2016. A marked decrease in panel 1.1.51 P's output (red curve) compared with the adjacent panels' output (green and blue curves) beginning on June 25, demonstrates the damaging effects caused by the hailstorm.

The graph for Site 2 shows failing panel **P1.1.51 P** compared to reference panels **P1.1.48 P** and **P1.1.52 P**.
